HURRICANE SANDY DAMAGE
RECOVERY IN THE EASTERN
REGION

SYSTEMATIZATION EXPERIENCES

**EXPERIENCE SHEETS ON POST HURRICANE SANDY
HOUSING RECOVERY PROCESS ON A LOCAL SCALE IN
MUNICIPALITIES OF THE PROVINCES OF SANTIAGO DE
CUBA AND HOLGUÍN**

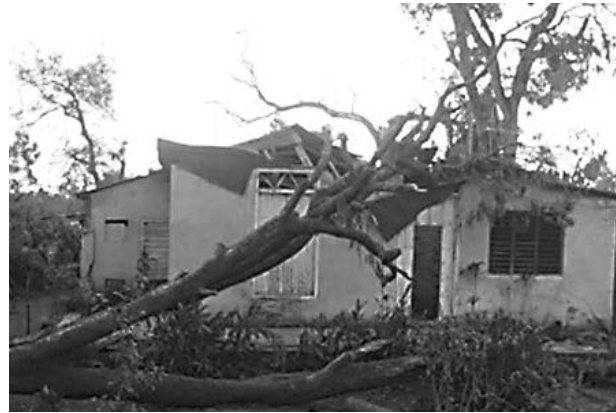
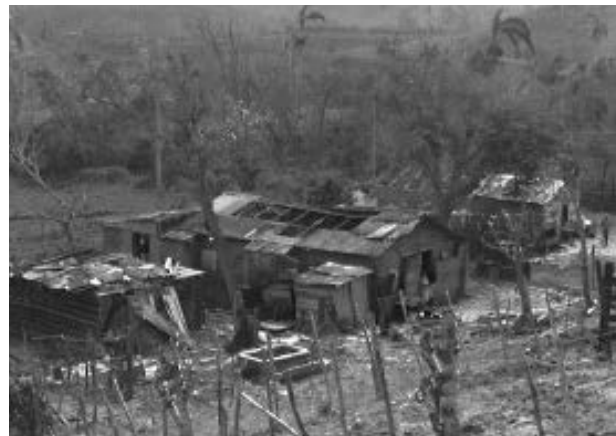
Fotos 1 y 2. Viviendas afectadas en el Consejo Popular de "El Caney", Santiago de Cuba

This weather event destroyed or severely damaged 179,314 houses, that is, 54.3% of the total (15,889 completely collapsed; 22,177 were partially destroyed; and 50,585 had total roof loss and 82,729 partial roof collapse). This posed an unprecedented challenge due to the need to assess the damage to a large number of affected houses in a short period of time. The idea was also to identify material needs in order to channel aid for the rehabilitation of the houses that could be repaired, thus helping affected families (Photos 1 and 2).

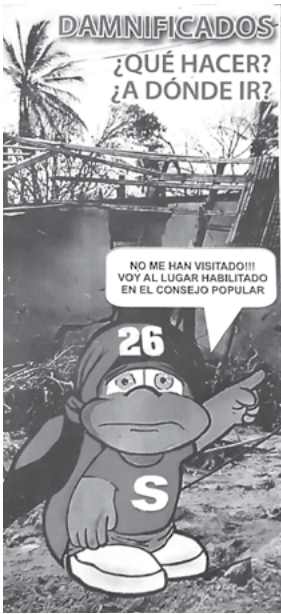
Figure 2

the relevant administrative procedures. This was supplemented with communication and information dissemination actions (Figure 2).

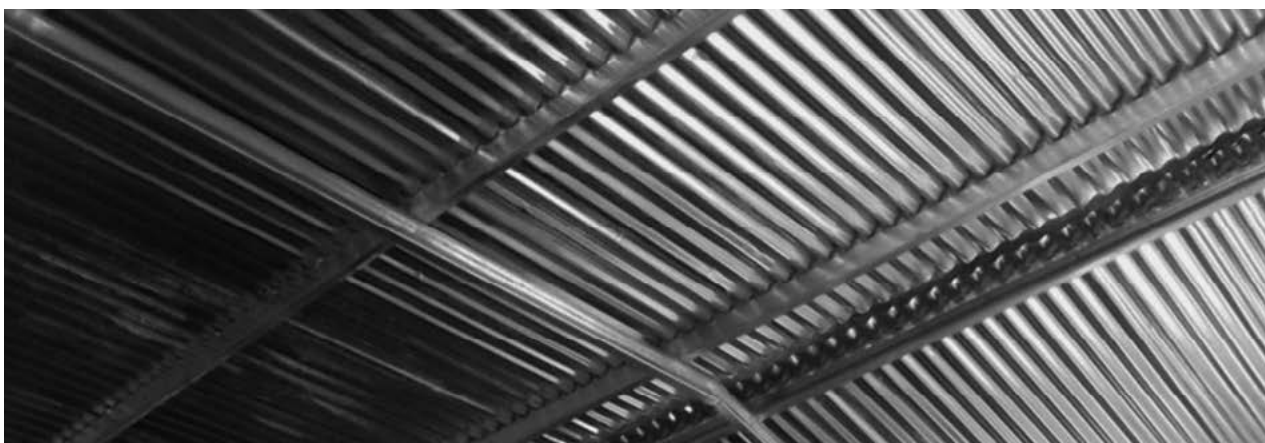
Figura 2. Soluciones emergentes de anclaje: A) Anclaje del purling al muro – B) Anclaje del purling con inserción en el muro

- A steel, L-shaped structure ($\emptyset \frac{1}{2}$) is inserted into the wall (Figure 2A).
- The minimum depth is at least half the thickness of the wall.
- The steel structure should go through the wall and get fixed at the other end.

- The steel structure is welded to the purlin, at a minimum distance equal to the web height.
- If there is any roof parapet, the purlin is introduced directly into the wall (Figure 2B).
- If there is any enclosure beam with no steel inserts, it is necessary to keep removing until one of the longitudinal steel structures appears. A brace is welded to the purlin (Figure 3).

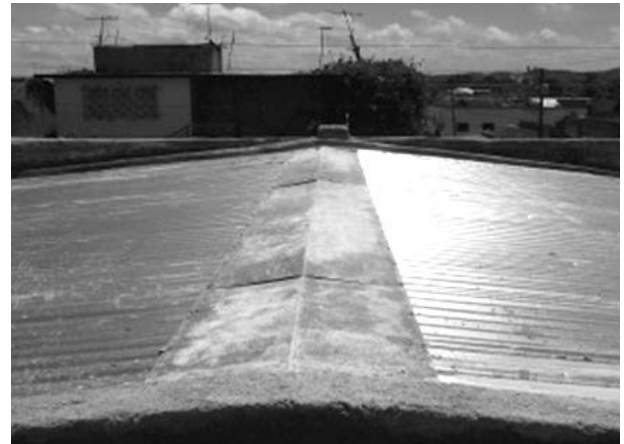
Fotos 5. Vista de los guardacandelas en una cubierta.

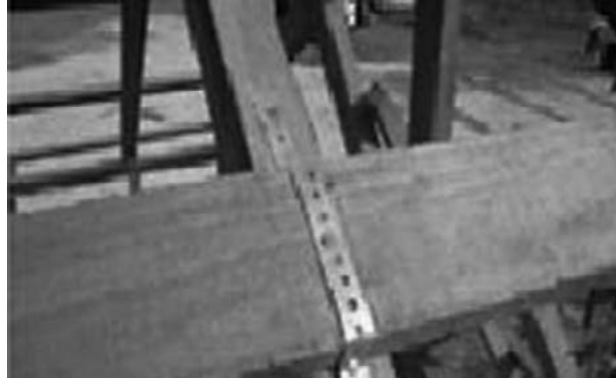
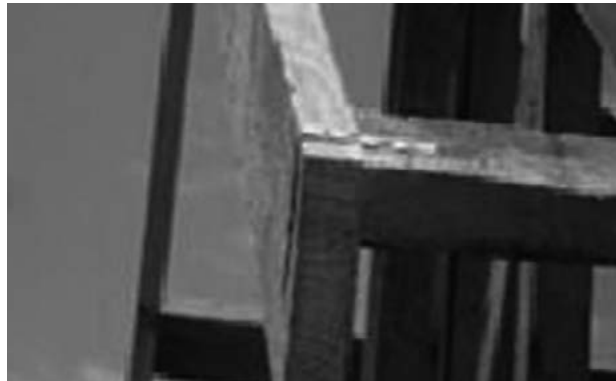
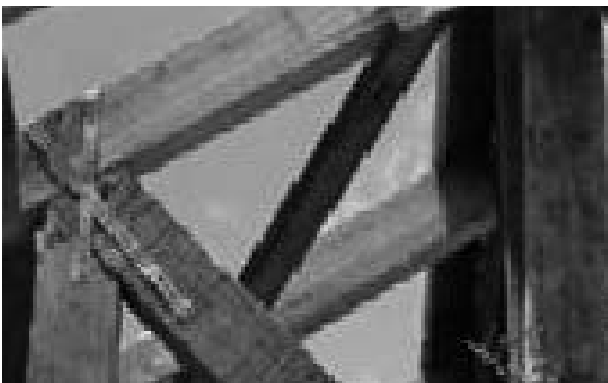
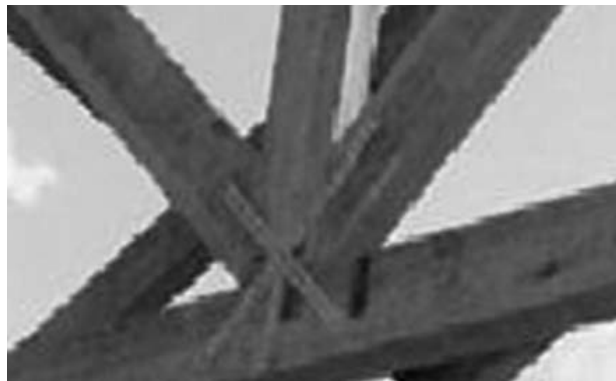
Photos 1 to 6. Different types of roof connections reinforced with strapping

Workshop participants were given practical training as to how to use strapping on different types of connections and structural elements of the roof (Figures 1 to 6). A new element introduced in the training process was the use of models, which provided a three-dimensional visualization of the elements, thus helping participants to understand how it is done (Photos 7 to 10), including diagrams on the most commonly used straps.

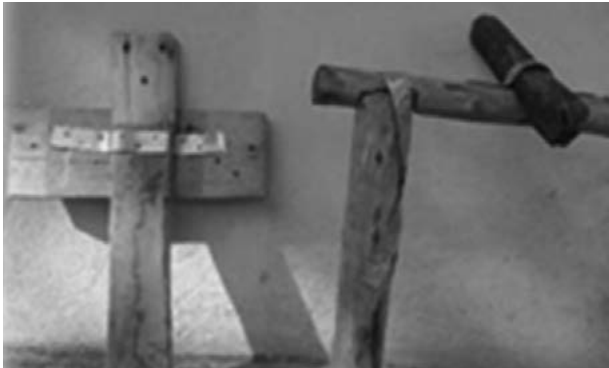
Photos 7 to 10. Structural connection models built for use in training workshops

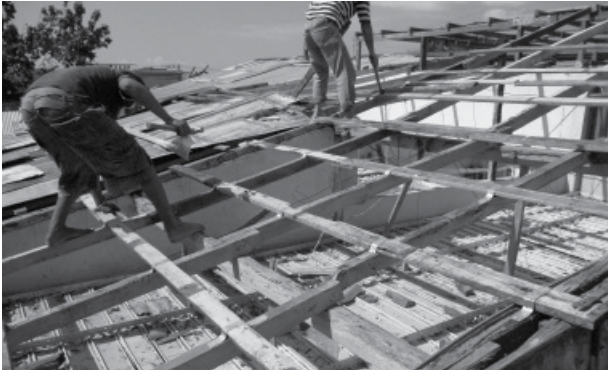
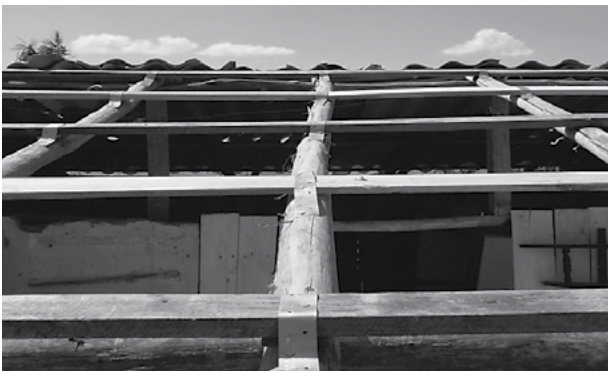
Photos 13 to 15. Connection of beams and purlins: 2 nails minimum at each end and on the beam

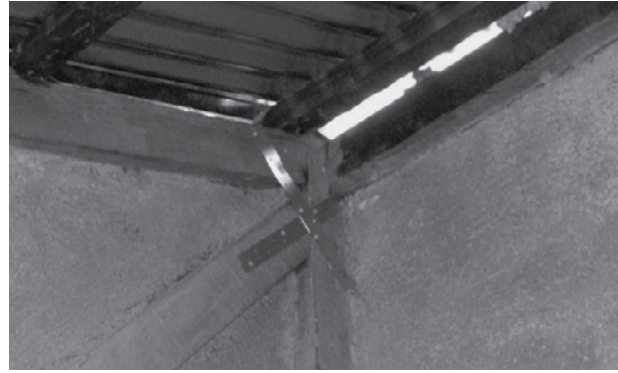
Photo 16. Strapping loop-type connection: the ends can be crossed and fastened at each end with at least 2 nails

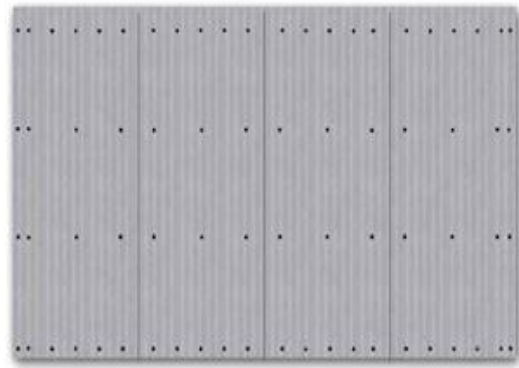
Figure 5. How to fix nails to binding tiles or corrugated sheets. For tile-tile connection, nails are fixed every 40 cm and for tile-structure connection, every 2 curves. For tiles on both ends of the roof, 2 nails are fixed on the first curves.

For installing zinc tiles, the general criterion was to secure strap adhesion into the structure using umbrella head nails and neoprene washers (Figures 4 and 5).

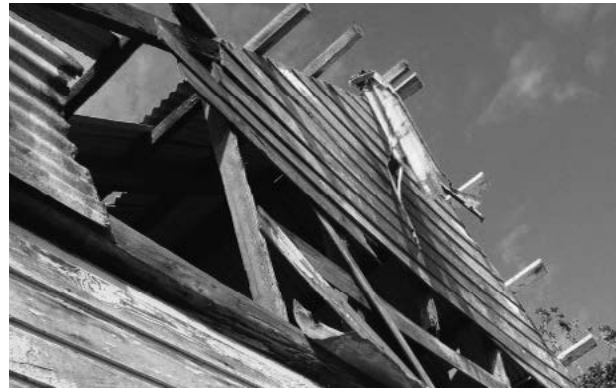
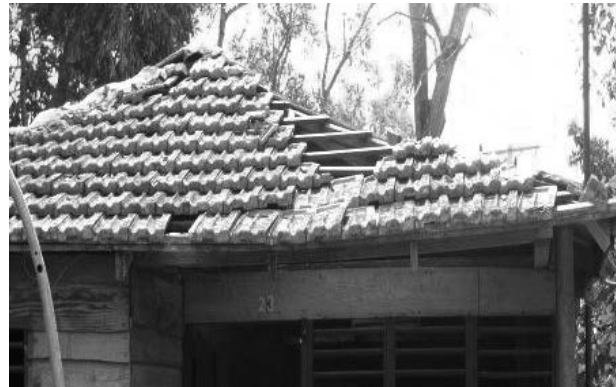
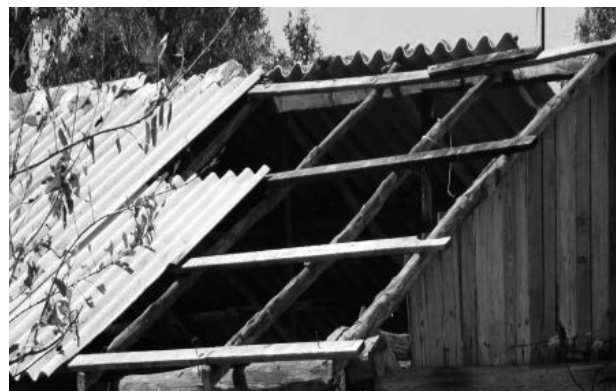
Photos 1 to 3. Construction situation of wood houses in the municipalities of Cueto and Báguanos before Hurricane Sandy hit

During the passage of the hurricane, a significant number of houses had their roofs removed altogether, basically wooden houses whose bearing structures and enclosures had deteriorated while the wooden structures, consisting of rafters and girders, were highly vulnerable. Also at risk were the roofs made basically of clay tiles and zinc and asbestos-cement sheets (Photos 1, 2 and 3).

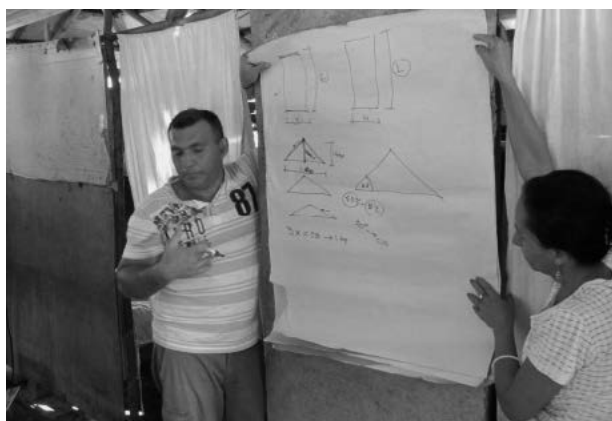
Photo 4. On-site technical training on the installation of new metal roofing elements on wooden structures in the houses damaged

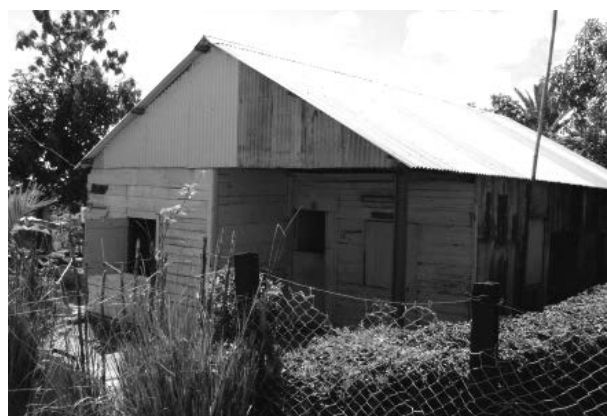
Photo 5. Wooden houses rehabilitated with new metal roofing in the municipalities of Cueto and Báguanos (Holguín province)

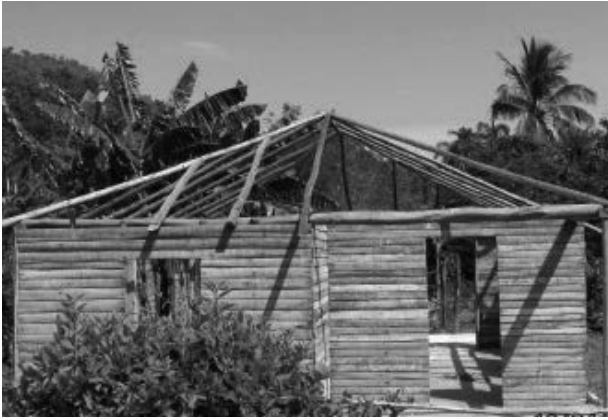
Photo 6. Levelling and preparation of bearing structure on one of the houses to be rehabilitated

Enclosure elements (wooden walls) were repaired or replaced, and the existing structure, consisting of wooden beams or bolsters and keys were also replaced, aligned or levelled (Photo 6).

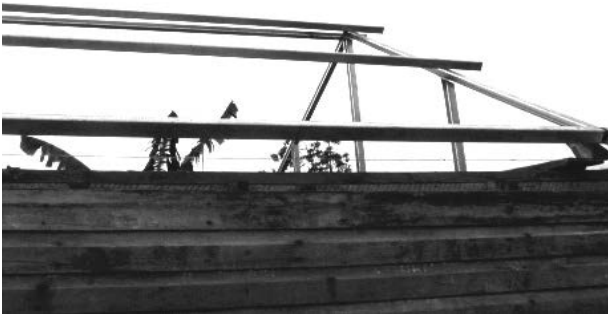
Photo 7. Framework or falsework with profile joists or purlins ready to be mounted on the wooden structure of a house under rehabilitation

This consisted in the mounting of two metal profile falseworks or frameworks, situated on the front and back lines of the house to be rehabilitated, while intermediate falseworks were built of wood, using recovered pieces from the original roof in such a manner that the spacing between them did not exceed 3.5 m (Photo 7).

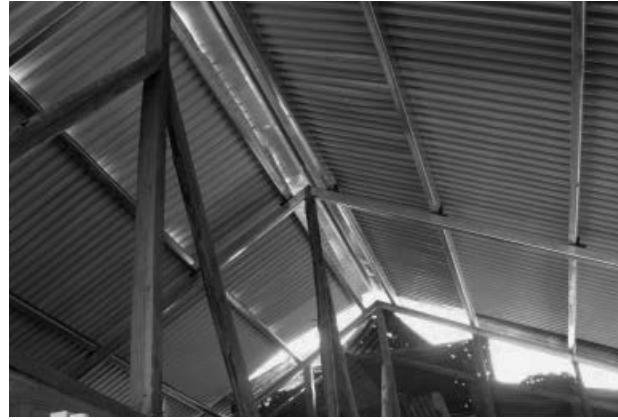
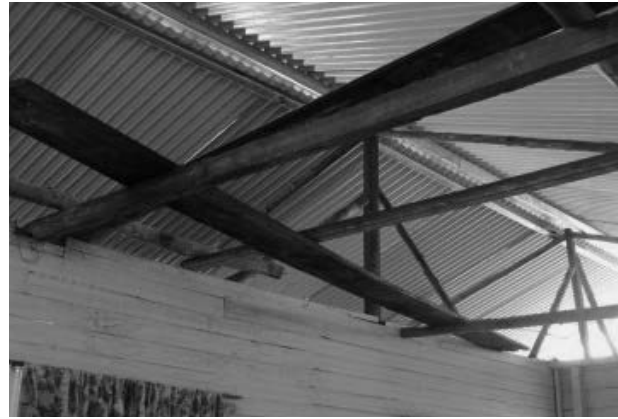
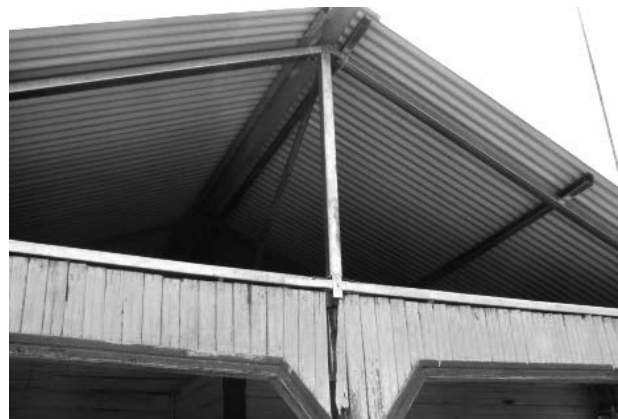
Photos 8 to 10. Detailed assembly and installation of new metal frame and roofing elements on wooden elements of the houses under rehabilitation

These elements determined the slope of the new gabled roof and also served as support for the rest of metal purlins or joists (Photos 8, 9 and 10).

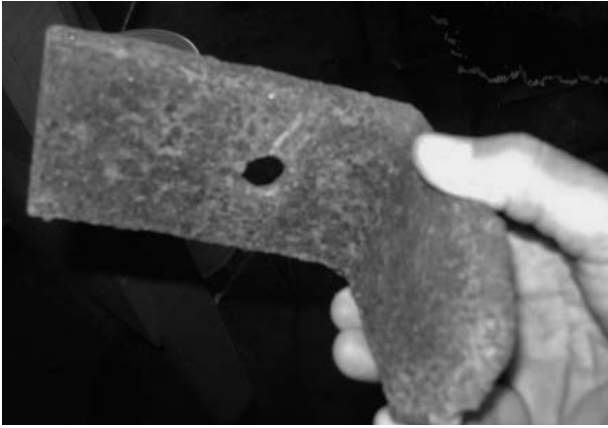
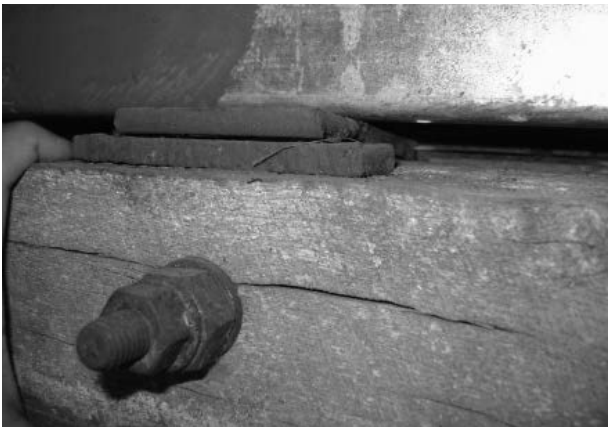
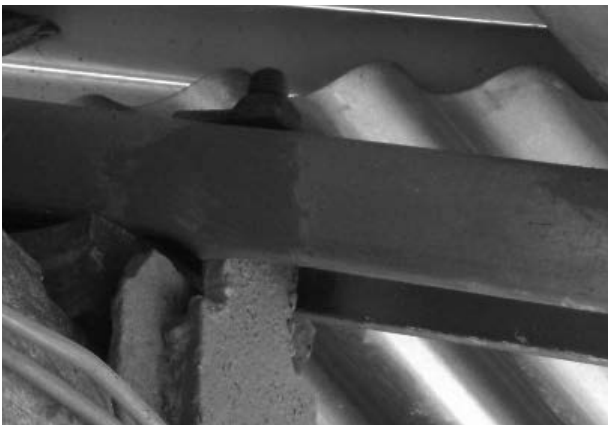
Photos 11 to 16. Detailed connection of metal frameworks or falseworks of the new roof on pre-existing wooden beams, using steel plates and threaded screws

An important issue to address over roofing is the connection of the metal falseworks with the wooden structure of the house, which was made through a number of specific solutions, using steel plates, both straight and angled (Photos 11 to 16), through bolts and nuts (Photos 17, 18 and 19), and other specific modalities based on the pressing need to find solutions (Photo 20).

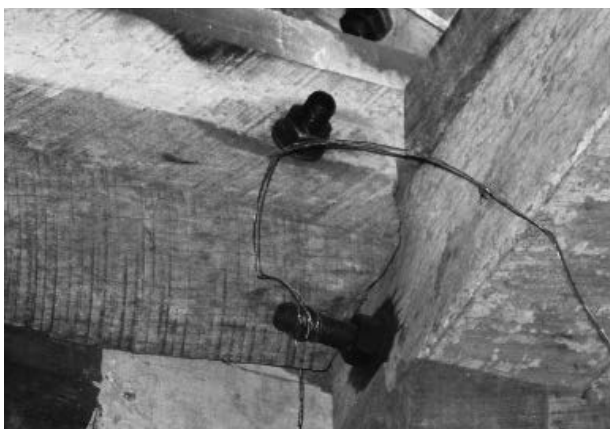
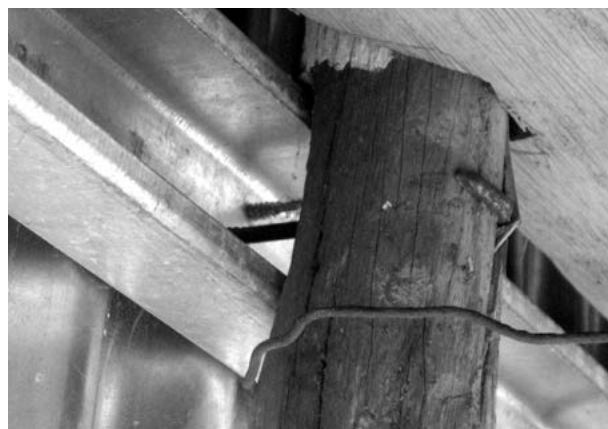
Photos 20. Detailed connection of metal structures of the new roofs on pre-existing structures applying various on-site solutions

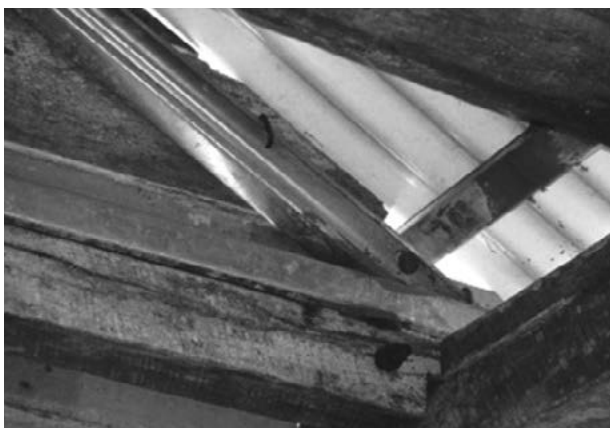
Photos 17 to 19. Connection of metal frameworks or falseworks with wooden beams using screws

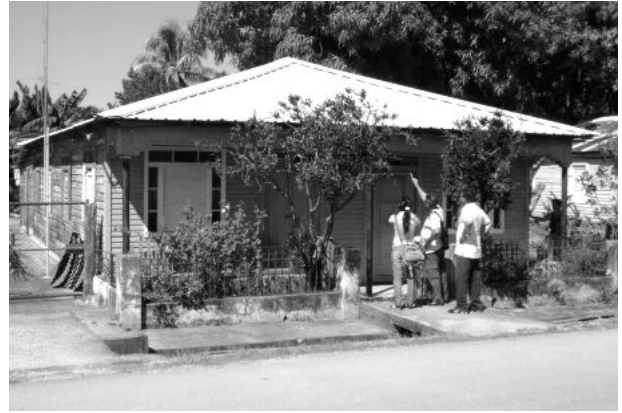
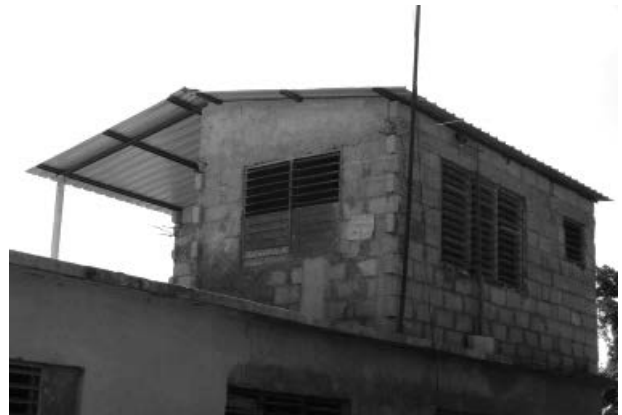
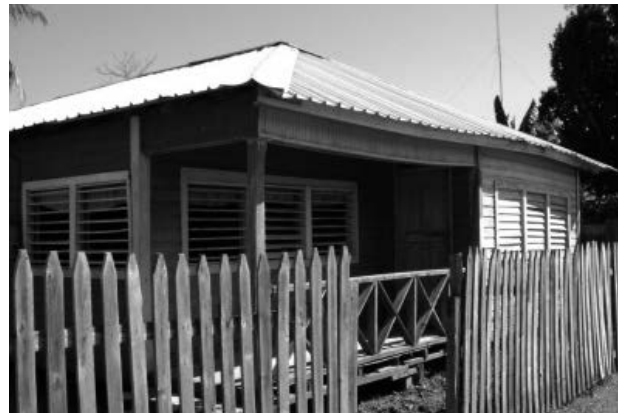
Photos 1, 2 and 3: Possible solutions applied to gabled and cross-gabled roofs on wooden or masonry structures

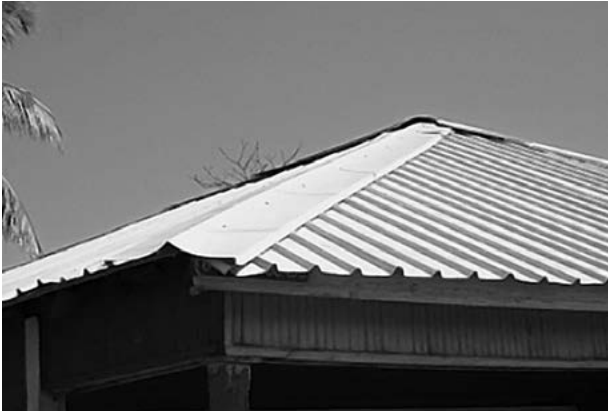
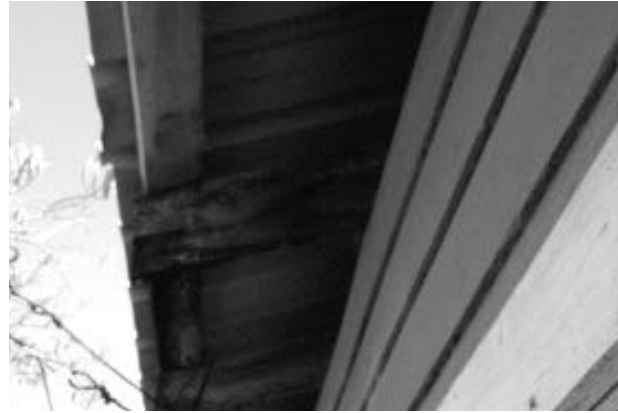
Photos 4 and 5: View of cross-gabled roofs with fretted metal tiles and supplementary pieces on ridges and junctions of sloping planes

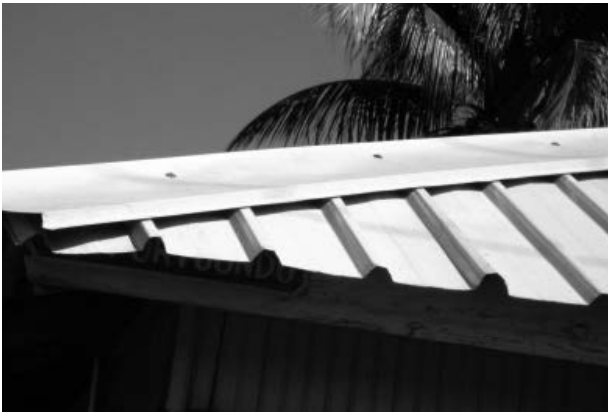
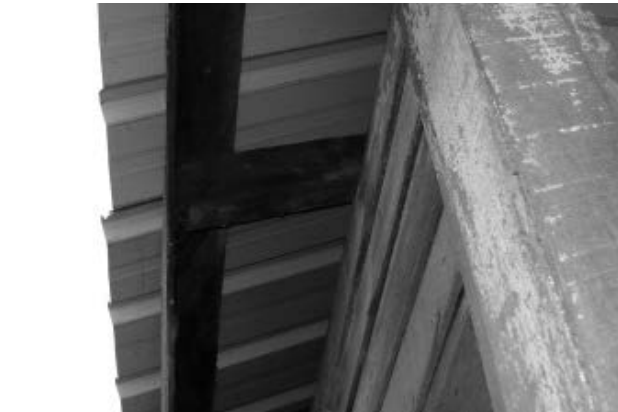
Photos 6 and 7: Re-use of wooden roof elements for the installation of laminated tiles on the roofing modules donated

With regards to houses with wooden walls and structures, remaining wooden elements in good condition were used. In other cases, good pieces of the damaged roof were re-used (Photo 6 and 7).

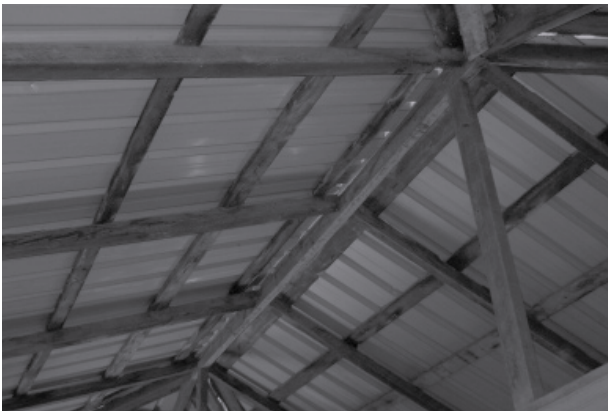
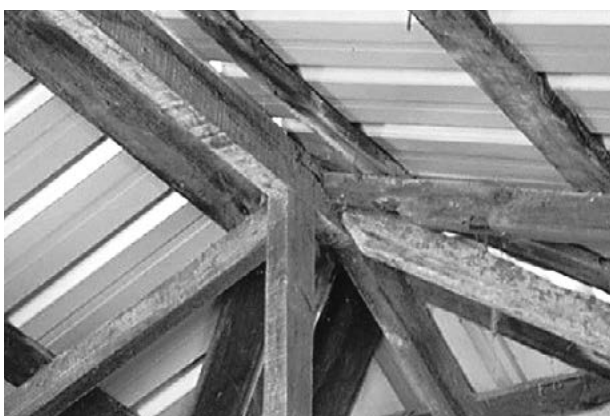
Photo 10.

Photos 8, 9 and 10: Re-use of original structural elements on masonry (brick and block) houses

The roofs installed either on wooden or masonry houses provided a quick and safe solution during the emergency phase itself, with the help of roofing brigades and the population affected by the hurricane. With regards to masonry houses with wooden roofs, original structural elements were re-used (Photos 8, 9 and 10).

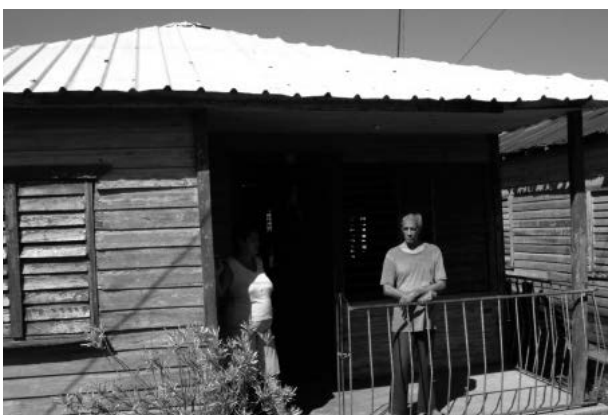
Photo 11: House completed with the roof module installed thanks to the Community Brigades and the beneficiaries themselves advised by local technical staff

It is imperative to highlight the organization of community-based roofing brigades trained by local UMIV technicians from both municipalities at theoretical and practical demonstration workshops held at the People's Council headquarters, with the attendance of the beneficiaries themselves, heads of the People's Power from neighbouring constituencies, and presidents of the People's Councils. This initiative ensured a greater participation and better quality of work, thus meeting the needs of the people affected by the hurricane in a short period of time (Photo 11).

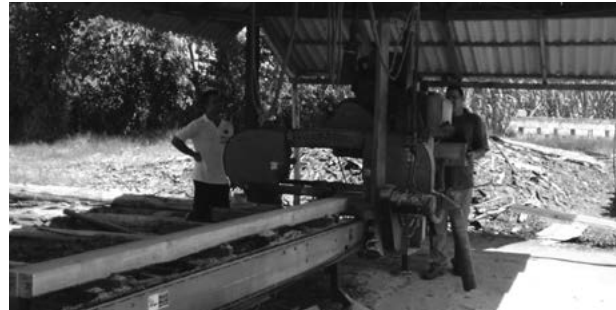
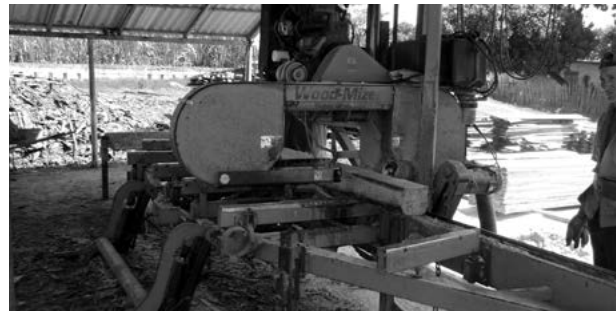
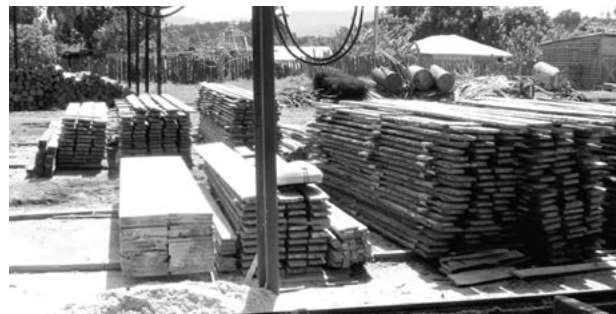
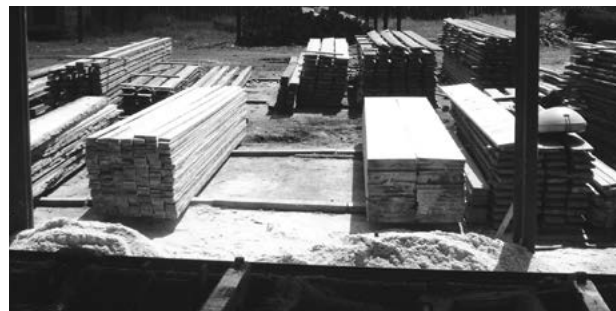
Fotos 1 y 2

It was decided the use of two mobile sawmills, of small dimensions and possible transportation (Photos 1, 2 and 3), which allow sawing wood in

situ (Photos 4 and 5), reaching the most difficult areas and significantly reducing the transportation costs of raw materials.

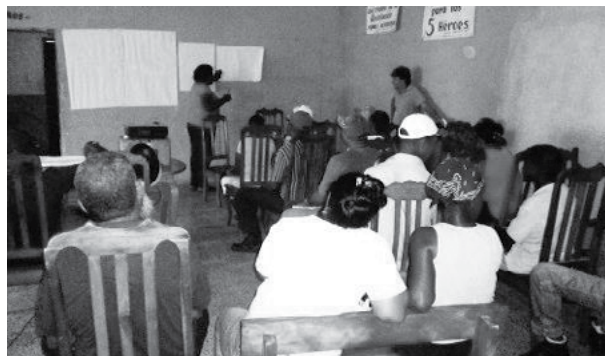
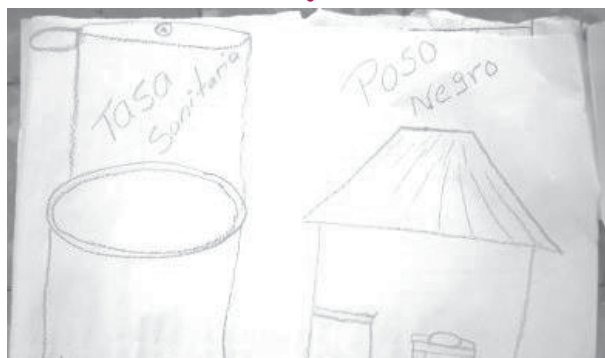
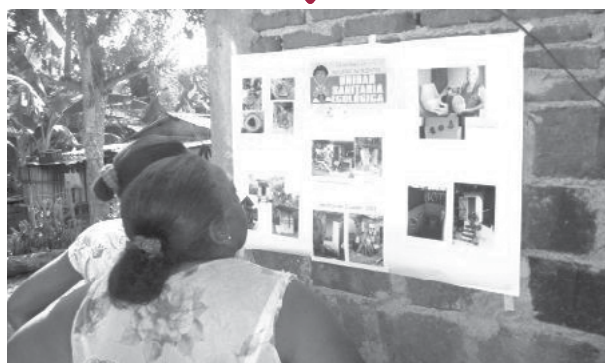
Step 2. Selection of the site for the toilet, adaptation of the original design, and layout of the work.

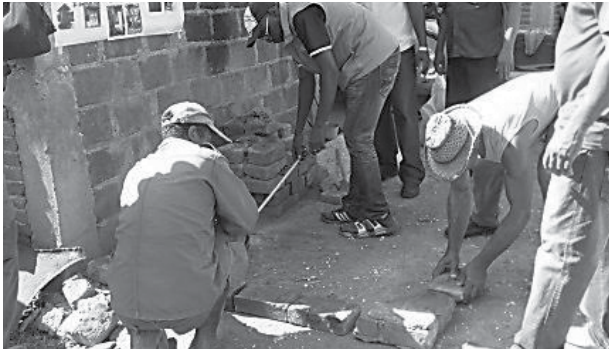
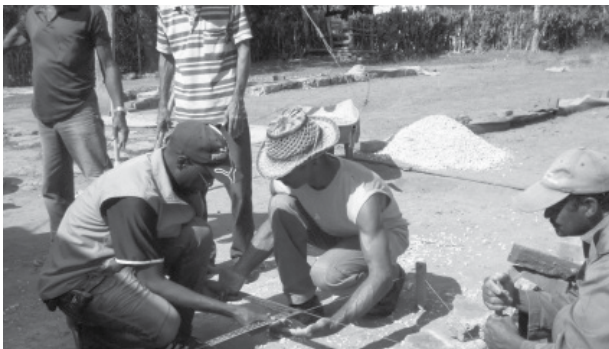
Step 4. Assembly of the toilet bowl with a urine separation system.

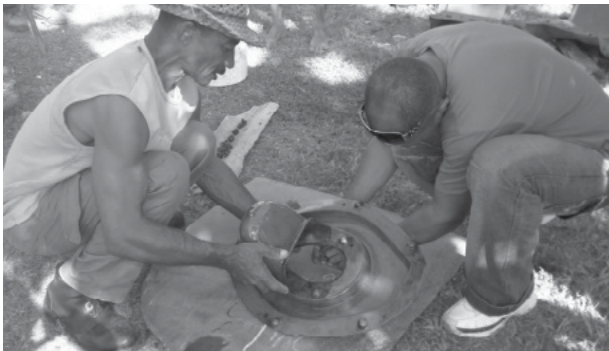
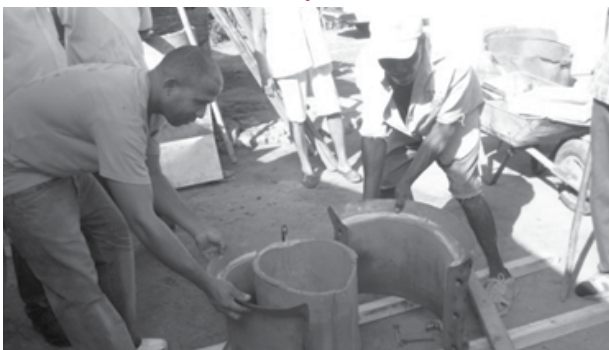
Step 3. Erection of the work.

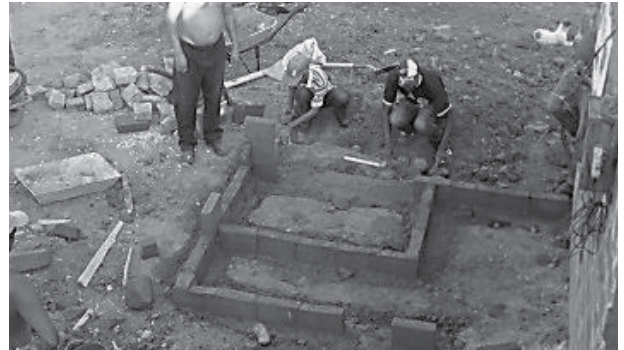
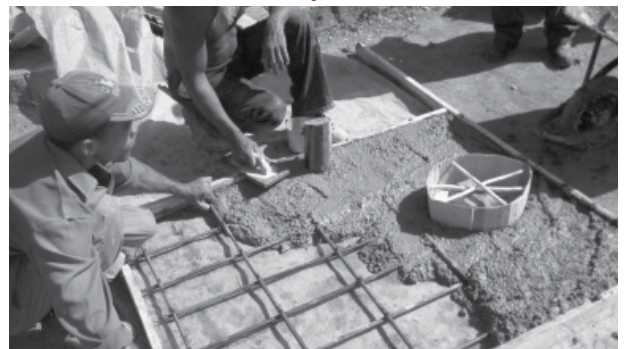
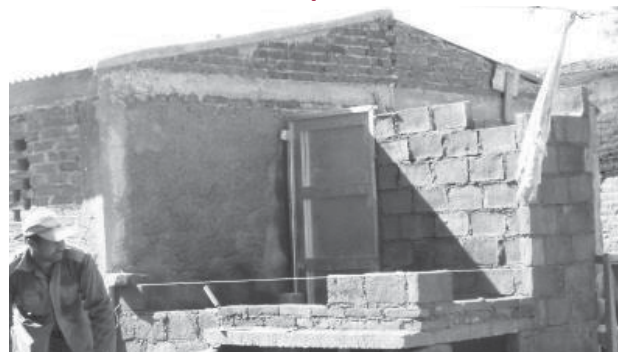
Step 5. Accessories and finishing solutions.

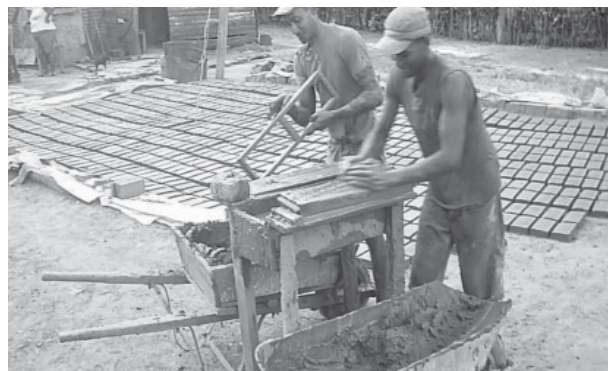
Locally produced bricks

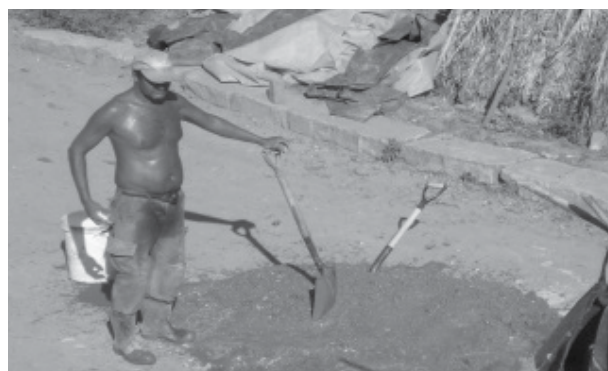
Mix preparation

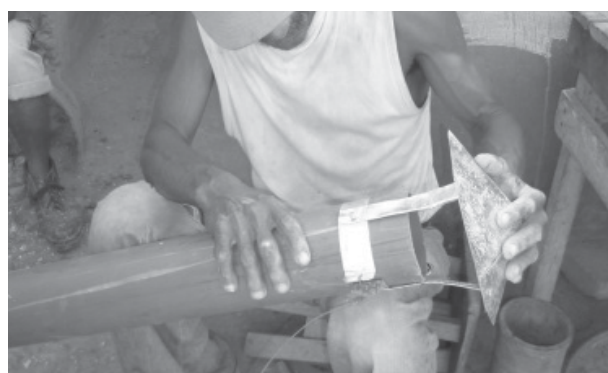
Vent assembly

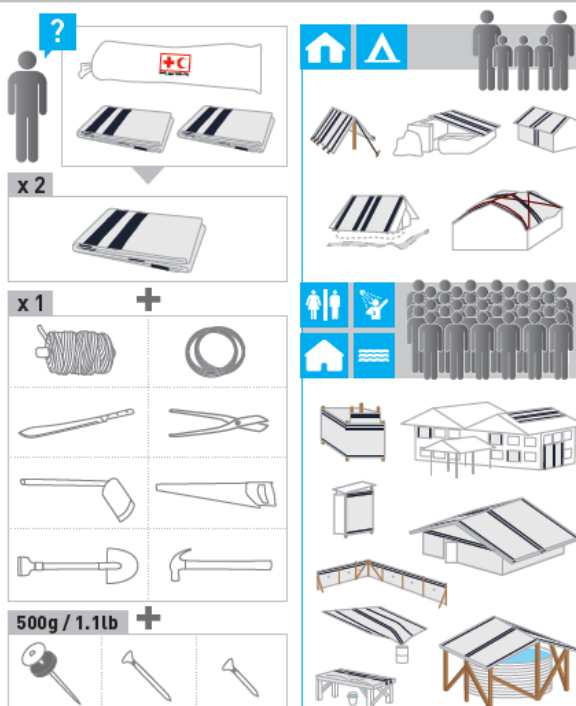
Figura 5. Contenido del volante de instrucciones a la población y brigadas de techado, distribuido por la Cruz Roja Cubana en Santiago de Cuba.

4. To avoid sharp points: Plastic sheeting is easily punctured by sharp points or worn away by rough surfaces. When building a frame for plastic sheeting it was ensured that edges and rough surfaces in contact with the plastic had been smoothed. External objects such as tree branches can puncture plastic sheeting. In that sense, for a better understanding, the Red Cross distributed booklet guides on the specification and uses of plastic sheeting in (Figure 5).

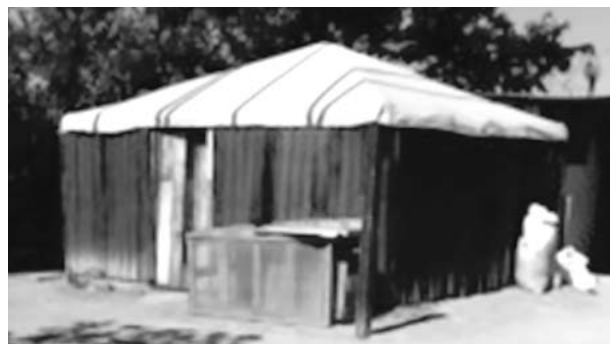
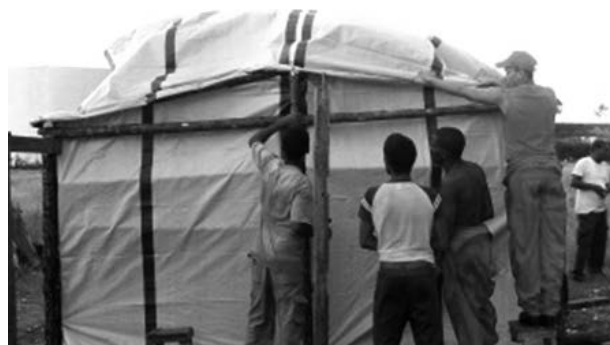
Foto 1 y 2. Soluciones emergentes construidas con los módulos No. 2 (arriba: donante PNUD) y No. 3 (abajo: Federación Internacional de la Cruz Roja y la Media Luna Roja)

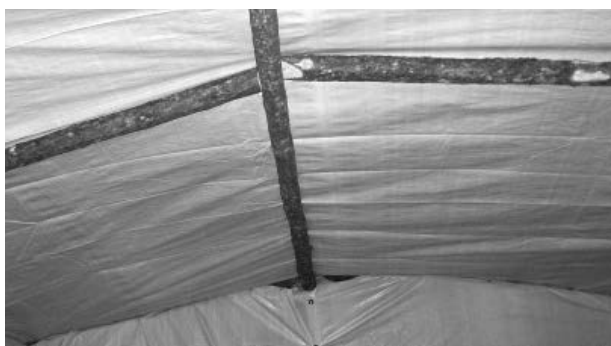
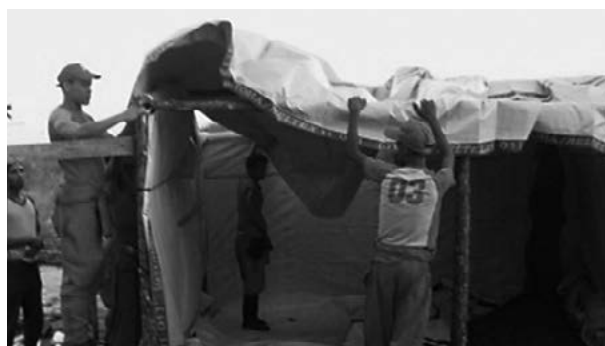
Fotos 3 y 4. Refugio temporal de lonas de plástico (carpulinas) en Loma Caballo Blanco, barrio afectado en Santiago de Cuba.

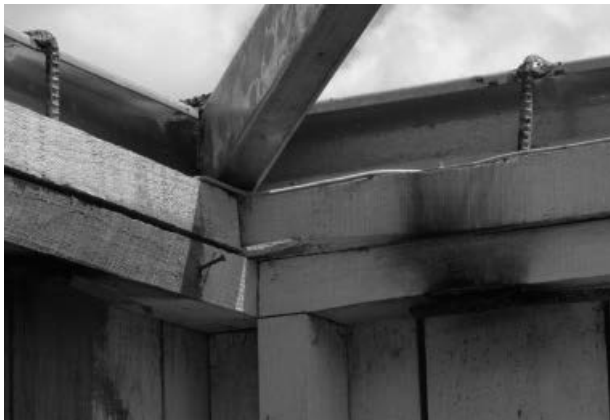
Foto 4. Detalle de montaje de purlings de techo de estructura metálica sobre estructura de madera.

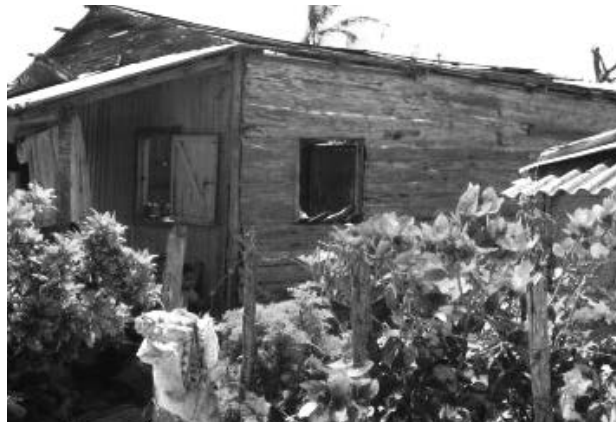
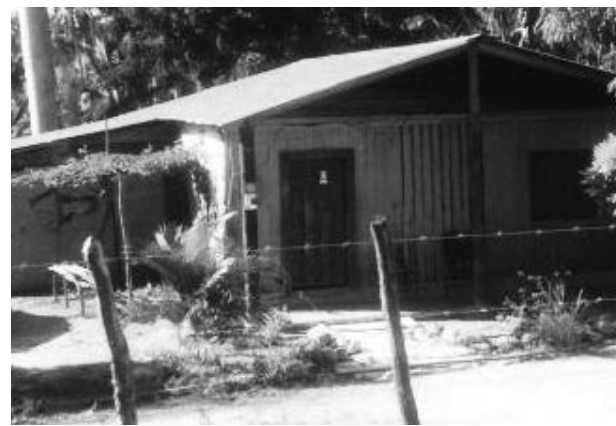
- Analysis of specific solutions for the placement of ceilings in houses built with prefabricated systems designed to receive another solution of roofing (photos 5 and 6).

Fotos 5 y 6. Vivienda beneficiada antes (arriba) y después (abajo) de la intervención.

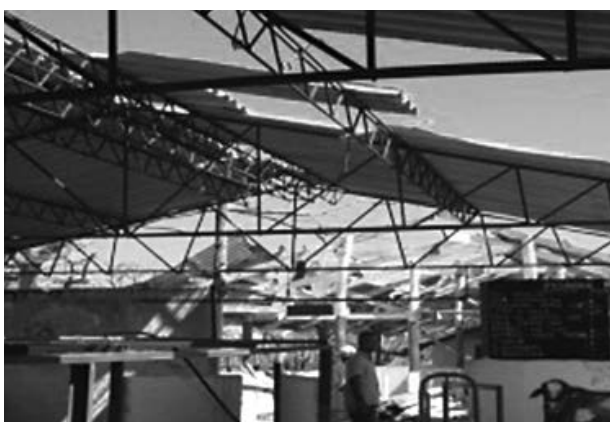
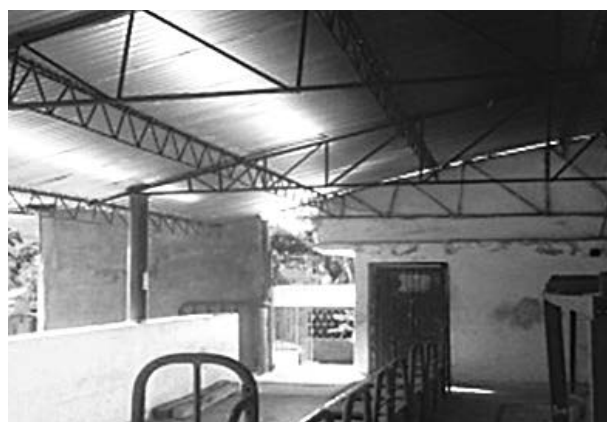
moted structural solutions for achieving other type of durable tie and/or strongly enough for load purlings (Photo 7).

Fotos 7 y 8. Instalación agropecuaria beneficiada antes (izquierda) y después (derecha) de la intervención.

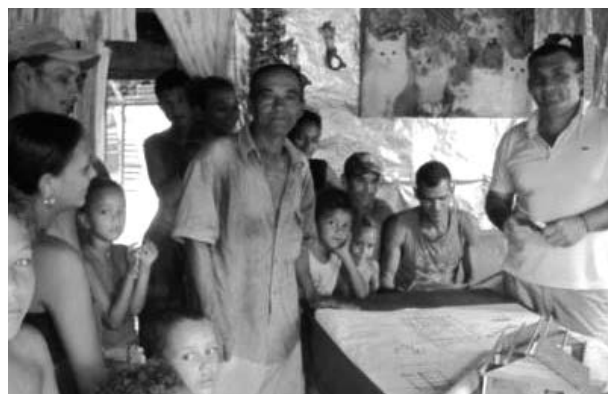
Foto 3.

steps to support families in the actions of preparation, such as, strengthening the structures and building mojinetes in the case of masonry houses (Photo 3).

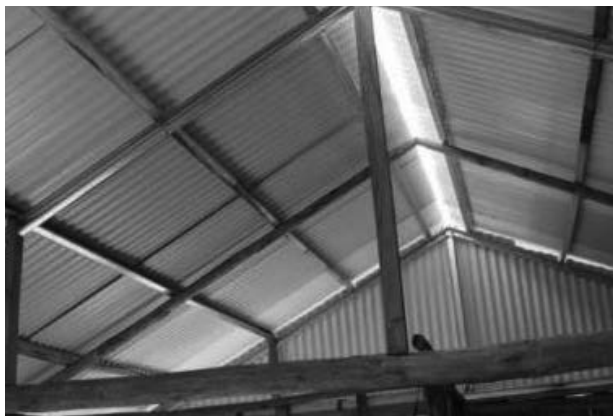
Foto 4.

the general basic principles for the construction of ceilings resistant to hurricanes and models for training support were prepared (Photo 4).

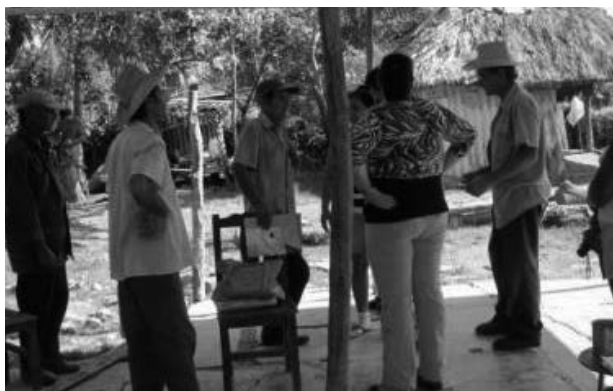
Foto 5.

families with the willingness and ability to build school ceilings were selected. Fifteen houses and its ceilings became prototypes to be followed by the benefited communities as examples of good practices (Photos 5 and 6).
